# LRV 1137 Roof Repair Change Order Request

October 4th, 2024

# Repair Summary: February - June 2023

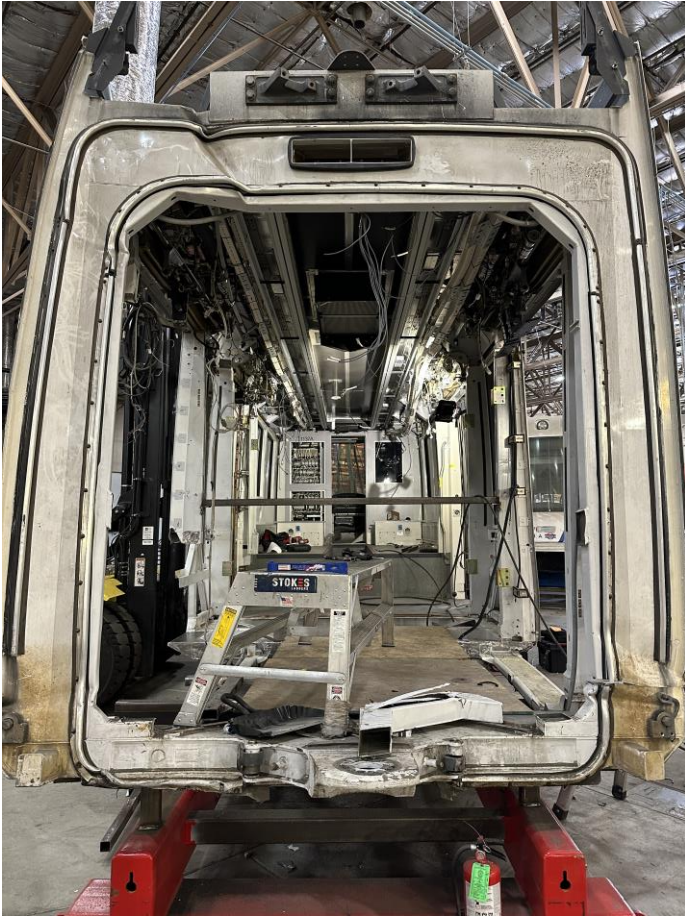
- Damage at articulation portal
- Roof damage behind this panel

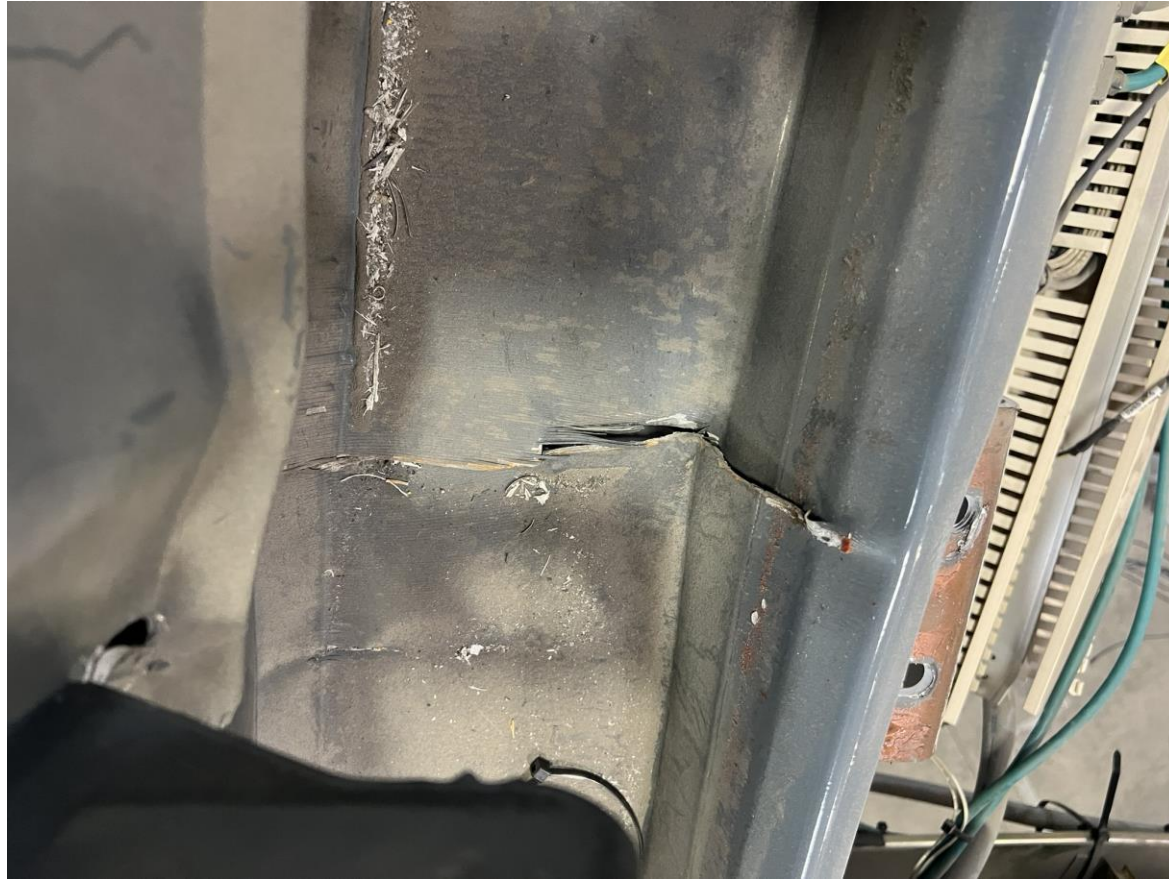
- Damage observed after sidewall was cut away

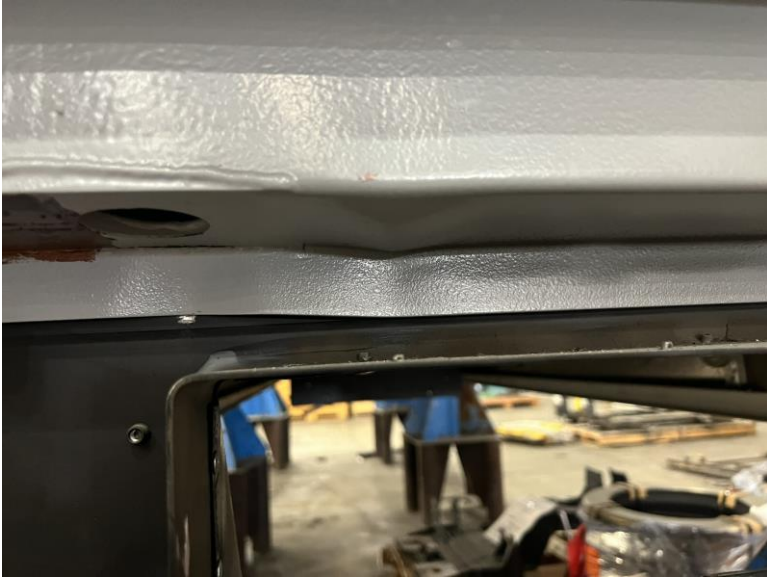
- Damage prior to repair (close up)

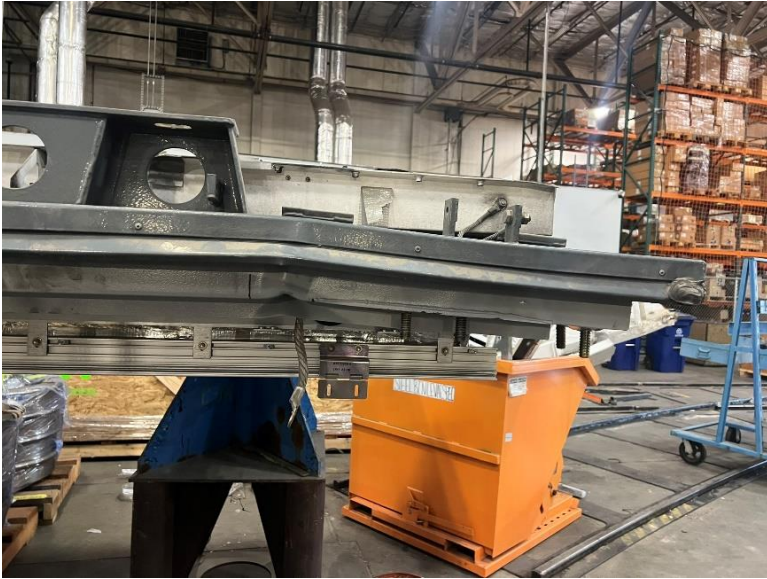
- Damage prior to repair

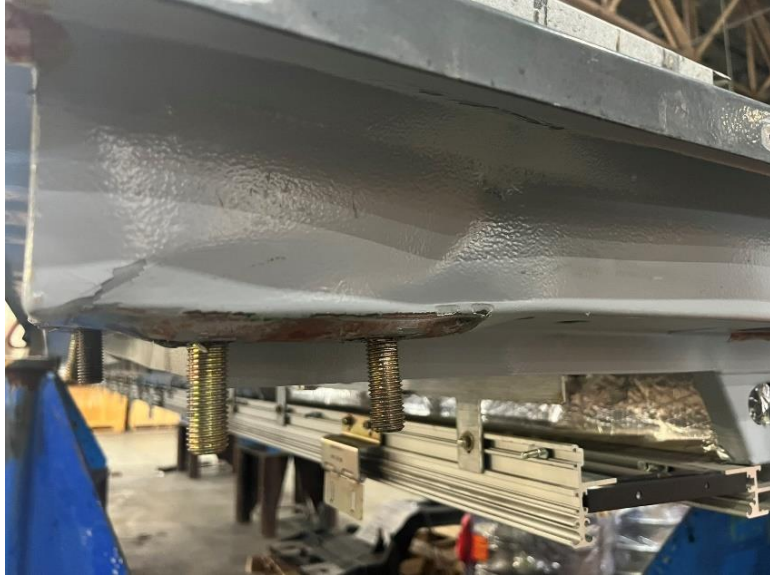
- Damage prior to repair
