# UTA 🚔 FACILITY DEVELOPMENT

# FACILITY STRATEGIC PLAN

MAY 2025 | DRAFT

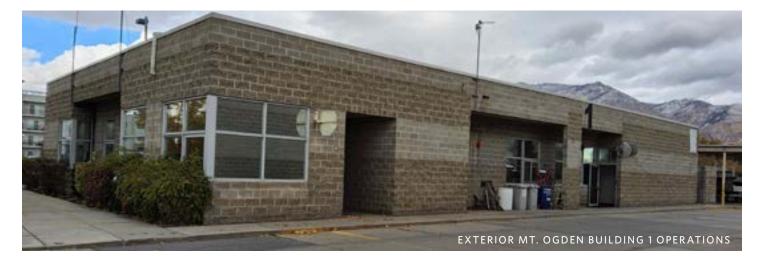
# Mt. Ogden | Operations

Mt. Ogden Building 1 Operations building includes offices, dispatch, drivers lounge, exercise room, locker rooms, and a break room.

Operations has outgrown this building. A new building is in design, with an anticipated completion of construction in the summer of 2027. Building 1 will be retained and will provide a useful space for other departments in the highly constrained campus. Future remodel of this building should include upgrades to the Electrical, Fire Suppression and Security deficiencies identified.

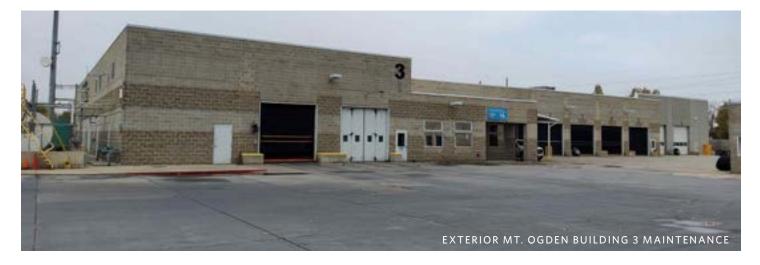
Mt. Ogden building 3 serves the maintenance needs of the current Mt. Ogden bus fleet, including battery electric buses for OGX. Facilities maintenance and road crew also utilize this facility.

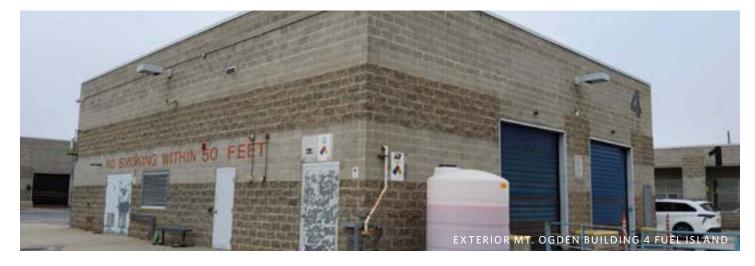
Mt. Ogden Building 2, Guard and Fare Processing, includes security guard office and bus fare collection. Mt. Ogden Building 4 Fuel Island houses equipment for bus fueling and servicing.

Fuel storage tank replacement/modernization is planned. Bus canopy expansion will be required to accommodate additional revenue vehicles. Notable risks for future include: campus configuration, storm water management, and employee parking.

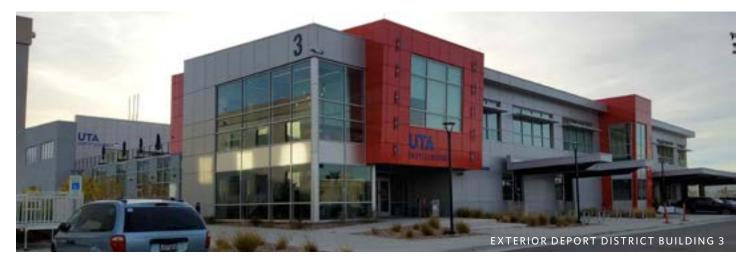
Depot District houses Administration, Operations and Maintenance for the Salt Lake Service Unit.

New building in excellent condition and well maintained. Warranty expired early 2025 and minor reconfiguration projects are expected.

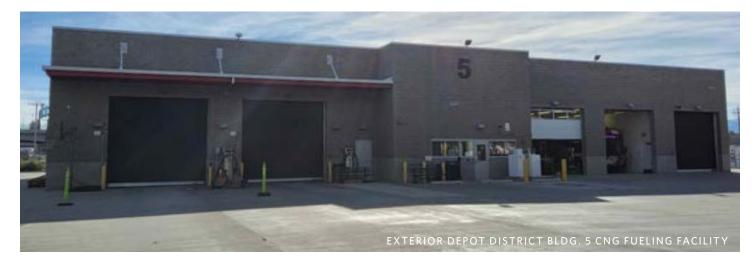
The Depot District Bus Wash facility is used for bus washing operations and contains two wash bays. The CNG Compressor Building consists of a flammable material storage building and a canopy over compressors. The Unleaded and Diesel Fueling Area is a canopy over the fueling equipment at the south end of the site and an adjacent tank farm. The Guard building contains two offices and is a single-story facility at the west entrance to the site.

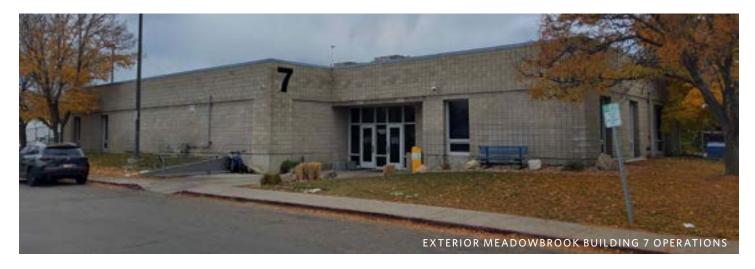
Meadowbrook Building 7 Operations building is a facility that includes office space, dispatch space, drivers lounge, exercise room, locker rooms, restrooms, and a lunchroom.

The most significant deficiency is the size of the building. Based on

over twice the size. A larger replacement building is needed.

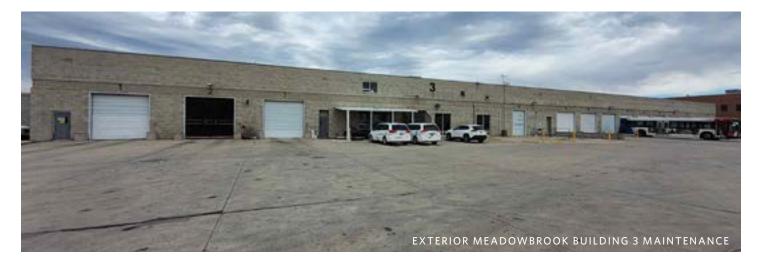
Meadowbrook Building 3 Maintenance building provides a comprehensive service facility for inspecting and repairing UTA's bus fleet vehicles. Additionally, the building has administrative offices, locker rooms, parts storage rooms, and a break room. A 2023 addition added seven maintenance bays to the building.

Ongoing repairs to the building resulting from the damaged fire suppression main will address many deficiencies. MB3 has sufficient maintenance space to support expansions in revenue fleet, however, spaces such as locker rooms, tool storage and areas for desktop work are overcrowded and will need expansion.

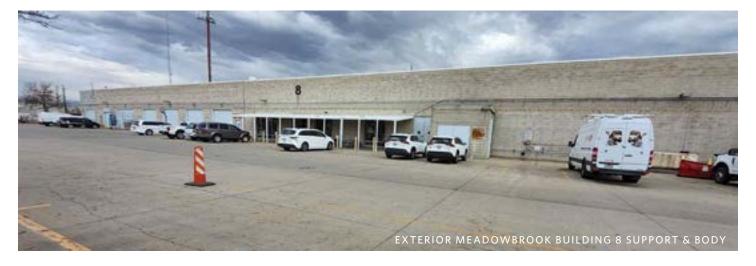
Meadowbrook Building 8 houses Maintenance Support & Body Work, including a machine shop, parts recieving department, and paint facilities. Additionally, Facilities Maintenance and Non-Revenue Vehcile maintenance support operate out of MB8.

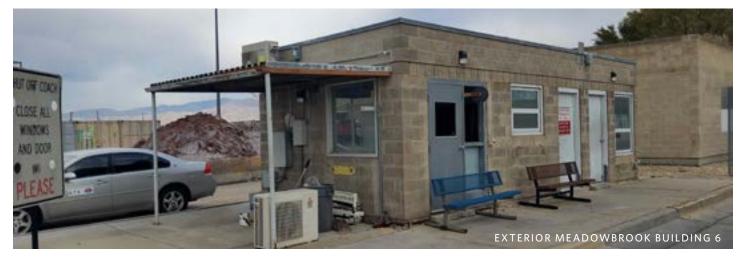
Meadowbrook Building 2 Fare Processing is an office building for fare collection. Building 4 Fuel Island includes equipment for bus fueling, currently only supporting diesel buses. The Bus Wash is contains five wash bays and Sign-Out Building 6 is a diminutive two-room office.

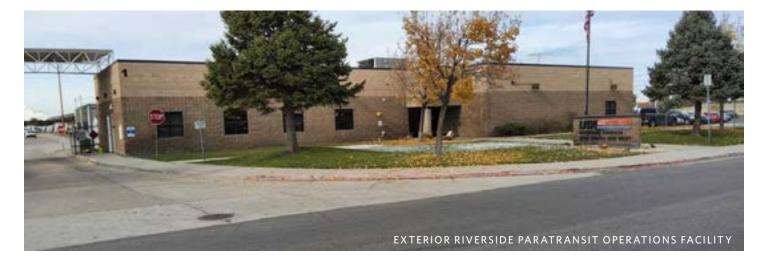
The UTA Riverside Paratransit Operations provides workspace for UTA's Paratransit services including operations, dispatch, scheduling, radio and control. The facility is supported by two relocatable buildings to accommodate an expanded workforce.

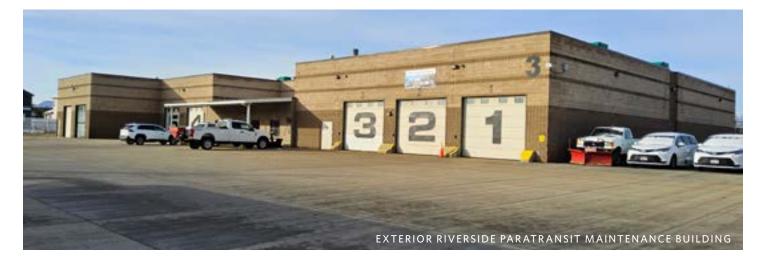
The Riverside maintenance building provides workspace for maintenance and service of Paratransit and Flex vans, including a space for tire maintenance contractor to work. The building also provides limited locker rooms and administrative work spaces.

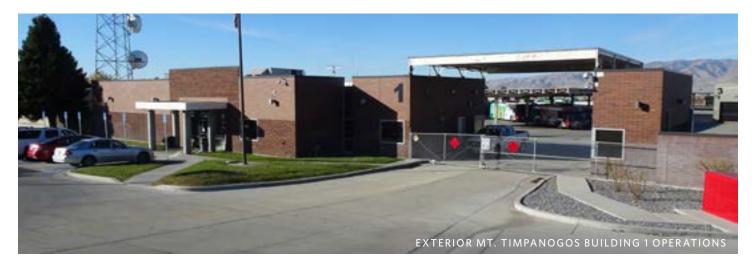
Mt. Timpanogos Building 1 Operations includes work and support spaces for Administration Operations and Dispatch. The building has overflowed into a complex of relocatable structures, which house office spaces, meeting rooms and network and radio infrastructure.

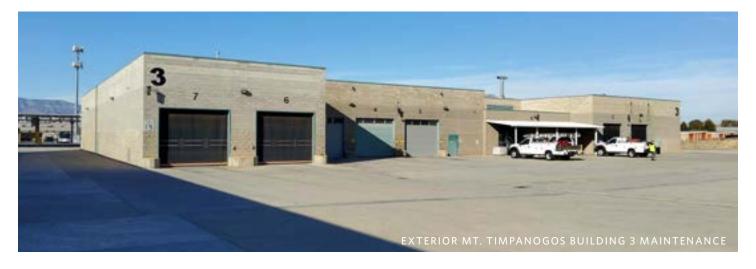
Mt. Timpanogos Building 3 Maintenance provides comprehensive service and maintenance capabilities for UTA buses. To meet the demands of UVX 60 ft articulated buses, an addition was constructed in 2007.

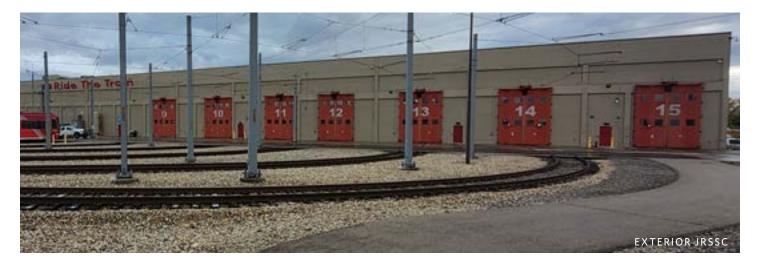
The UTA Jordan River Rail Service Center provides comprehensive services including storage, routine maintenance, and repairs. The building also hosts a large number of administrative functions and the TRAX control room.

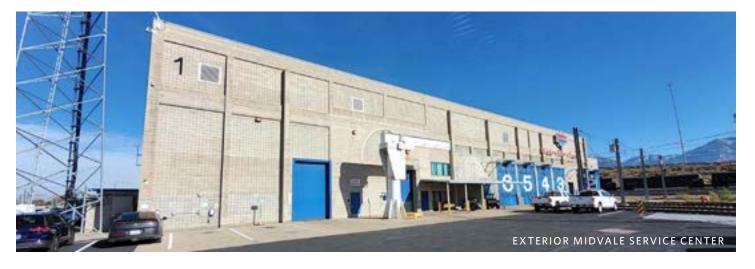
Midvale Rail Service Center was renovated to serve the opening of TRAX and the first generation of LRT vehicles at UTA. Midvale also houses the backup control room for FrontRunner.

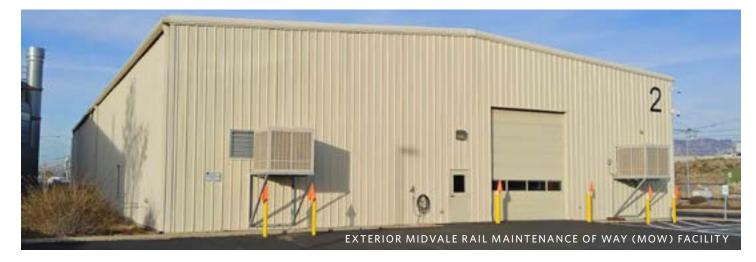
The Midvale Rail Maintenance of Way (MOW) Facility (Building 2) provides a full range of workspaces for the maintenance of tracks, signals, and other rail-related systems and Facility Maintenance. The Paint Booth (Building 3) is dedicated to painting and refinishing LRT vehicles and other large rail equipment.

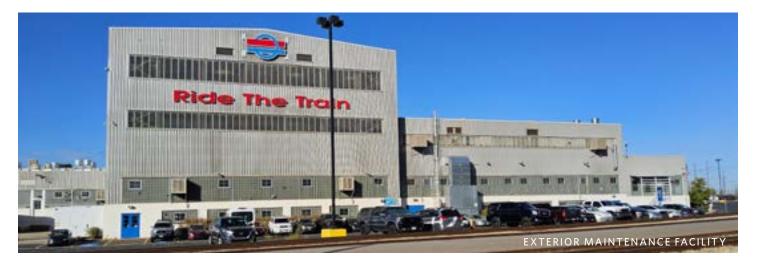
FrontRunner is operated and maintained through a single facility, Warm Springs Rail Service Center, which was built in 1952 as a locomotive assembly plant and adapted by UTA in 2008. The age of the facility and issues with the soils and site mean that there is a number of critical deficiencies, however the unique functions and near 24-7 operations of the building make necessary rehabilitation projects challenging.

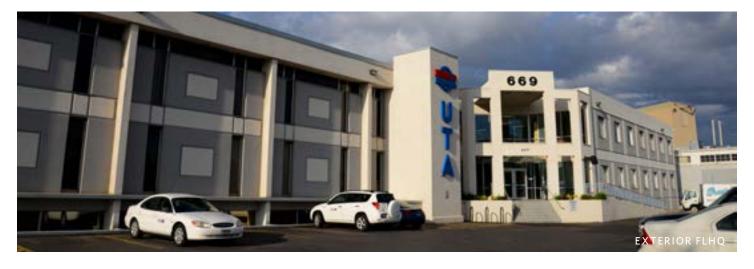
# **Depot District | Frontline Headquarters**

The UTA Frontline Headquarters (FLHQ) Campus consists of three buildings: East (1966), West (1991), and Connector (year unknown), serving as the primary facility for UTA's administrative and operational needs. The building has undergone various upgrades and additions over the decades, creating a complex infrastructure with mixed-generation systems, prompting the need for comprehensive seismic, architectural, and MEP renovations.

Sheer wall construction and wrapping of existing columns will require isting structure.

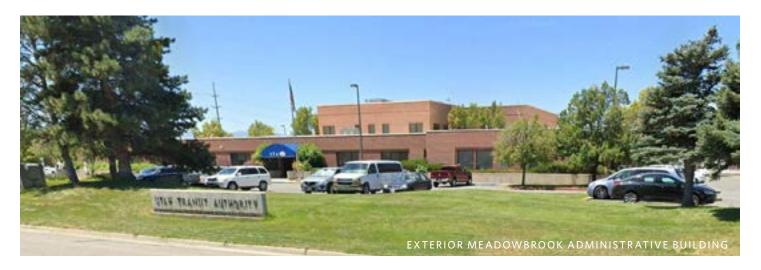
Meadowbrook Building 1 Admin. (MB1) building is a two-story facility that includes office spaces, restrooms, break room, storage rooms, classrooms, a healthcare center, and mechanical and electrical rooms.

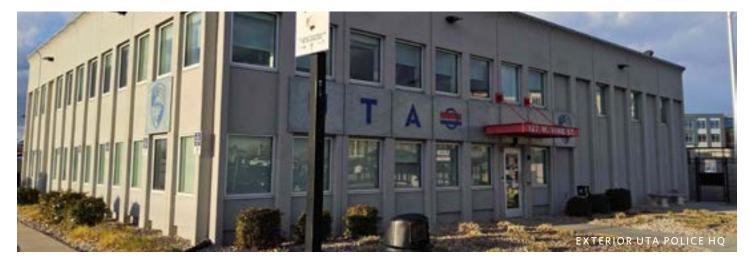
The UTA Police Headquarters serves as the operational center for the Utah Transit Authority Police Department. The building is designed to support the department's various functions, including patrol operations, investigations, K-9 units, and fare enforcement. Equipped with administrative offices, briefing rooms, and secure areas for evidence storage, the headquarters facilitates efficient law enforcement activities across the UTA transit system.
