FACILITY STRATEGIC PLAN:  
**CONDITION ASSESSMENT**

MAY 2025

LIGHT RAIL  
**Jordan River Rail Service Center | JRRSC**  
 2264 S 900 W, South Salt Lake, UT 84111

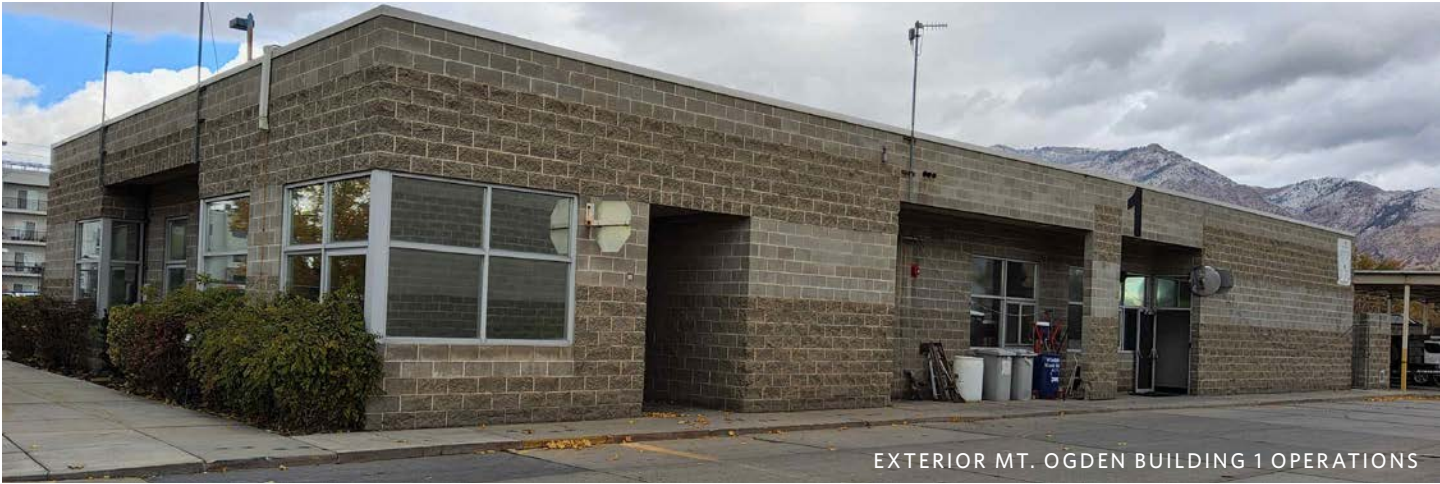
# Mt. Ogden | Operations

Mt. Ogden Building 1 Operations building includes offices, dispatch, drivers lounge, exercise room, locker rooms, and a break room.

Operations has outgrown this building. A new building is in design, with an anticipated completion of construction in the summer of 2027. Building 1 will be retained and will provide a useful space for other departments in the highly constrained campus. Future remodel of this building should include upgrades to the Electrical, Fire Suppression and Security deficiencies identified.

Electrical Distribution	Panelboards, interior distribution transformers, and interior fluorescent lighting system identified for replacement.	
	Electrical components and systems to be replaced as part of a multi-facility campaign or targeted individual projects.	
	Priority 1: Currently Critical	\$79,566

System Security	Security System has been identified for replacement.	
	Security System to be replaced as part of a multi-facility campaign or targeted individual projects.	
	Priority 1: Currently Critical	\$21,894

Fire Riser	Fire Riser identified for replacement.	
	Fire Riser to be replaced as part of a multi-facility campaign or targeted individual projects.	
	Priority 1: Currently Critical	\$3,738

Roof and Walkway Protection	PVC single-ply membrane roof as well as roof covering walkway protection has been identified for replacement.	
	Roofing repairs to be replaced as part of a multi-facility campaign or targeted individual projects.	
	Priority 2: Potentially Critical	\$78,035

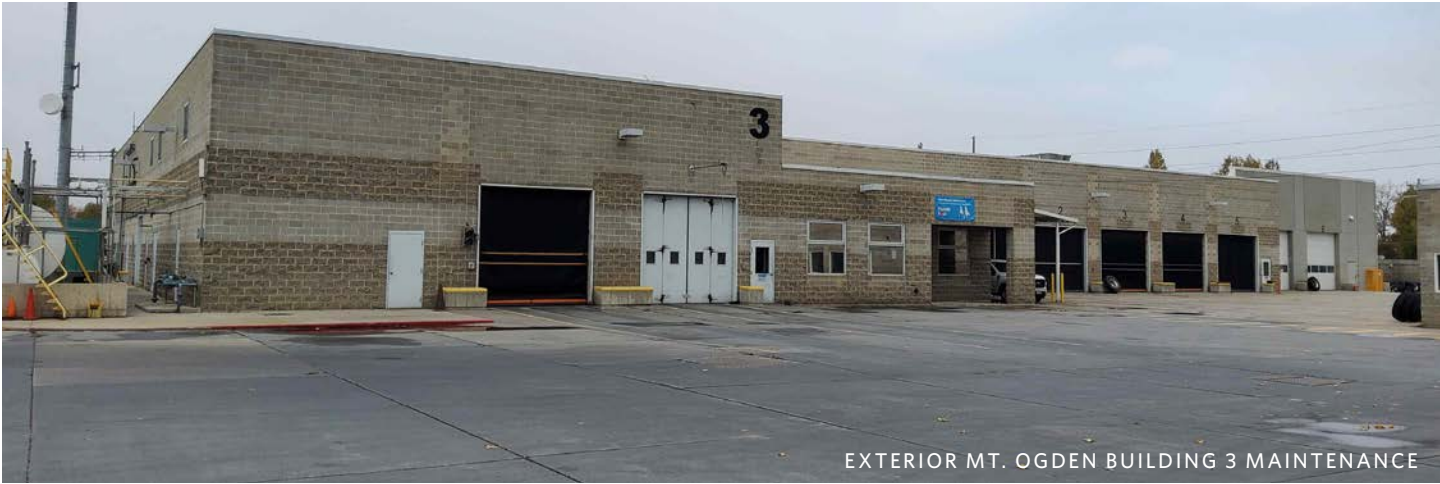
# Mt. Ogden | Maintenance

Mt. Ogden building 3 serves the maintenance needs of the current Mt. Ogden bus fleet, including battery electric buses for OGX. Facilities maintenance and road crew also utilize this facility.

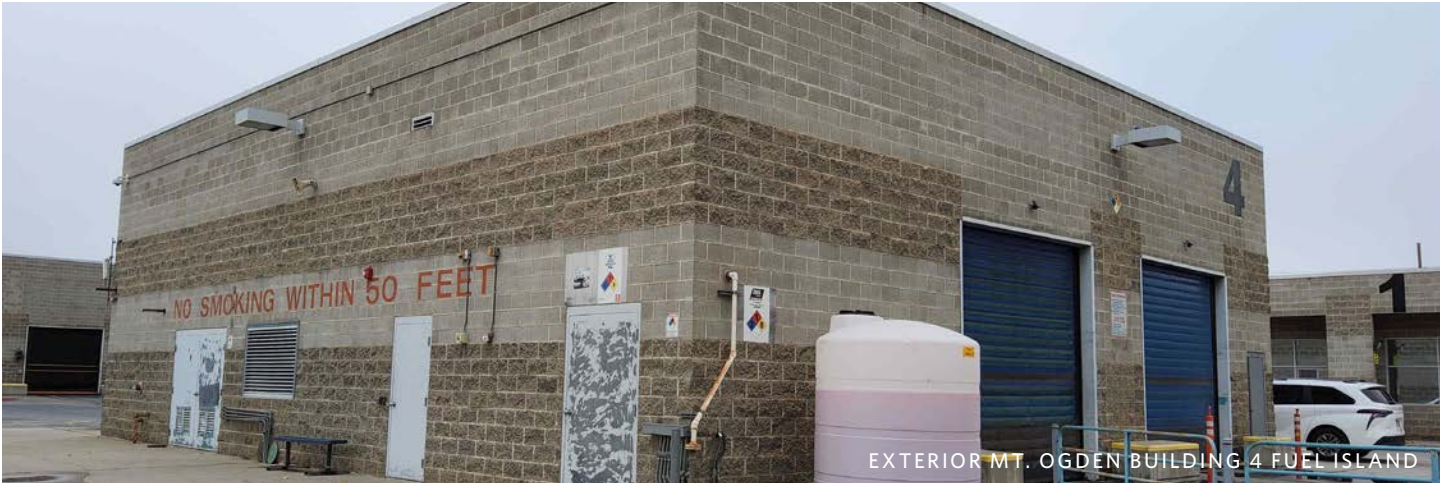
Mt. Ogden Building 2, Guard and Fare Processing, includes security guard office and bus fare collection. Mt. Ogden Building 4 Fuel Island houses equipment for bus fueling and servicing.

Fuel storage tank replacement/modernization is planned. Bus canopy expansion will be required to accommodate additional revenue vehicles. Notable risks for future include: campus configuration, storm water management, and employee parking.

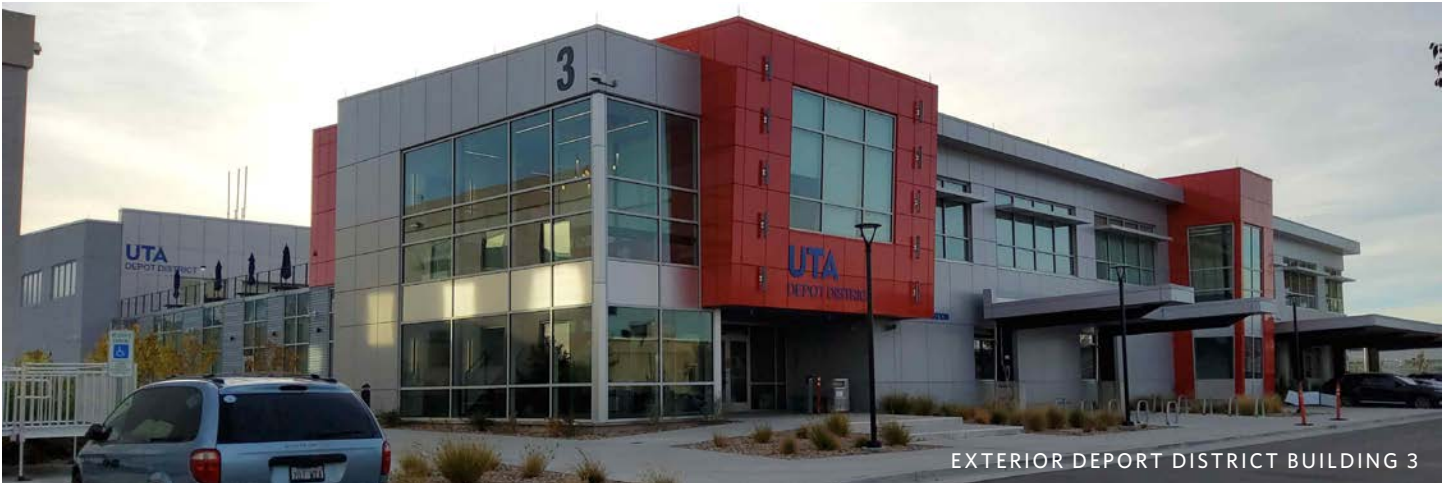
# Depot District | Main Building

Depot District houses Administration, Operations and Maintenance for the Salt Lake Service Unit.

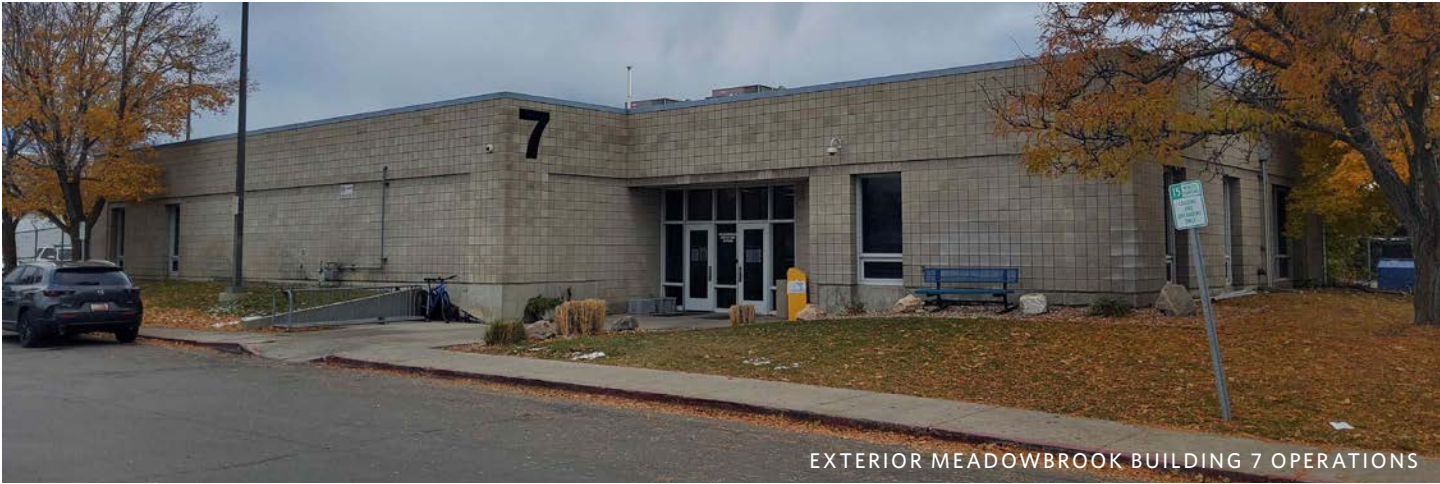
EXTERIOR MEADOWBROOK BUILDING 7 OPERATIONS

Meadowbrook Building 7 Operations building is a facility that includes office space, dispatch space, drivers lounge, exercise room, locker rooms, restrooms, and a lunchroom.

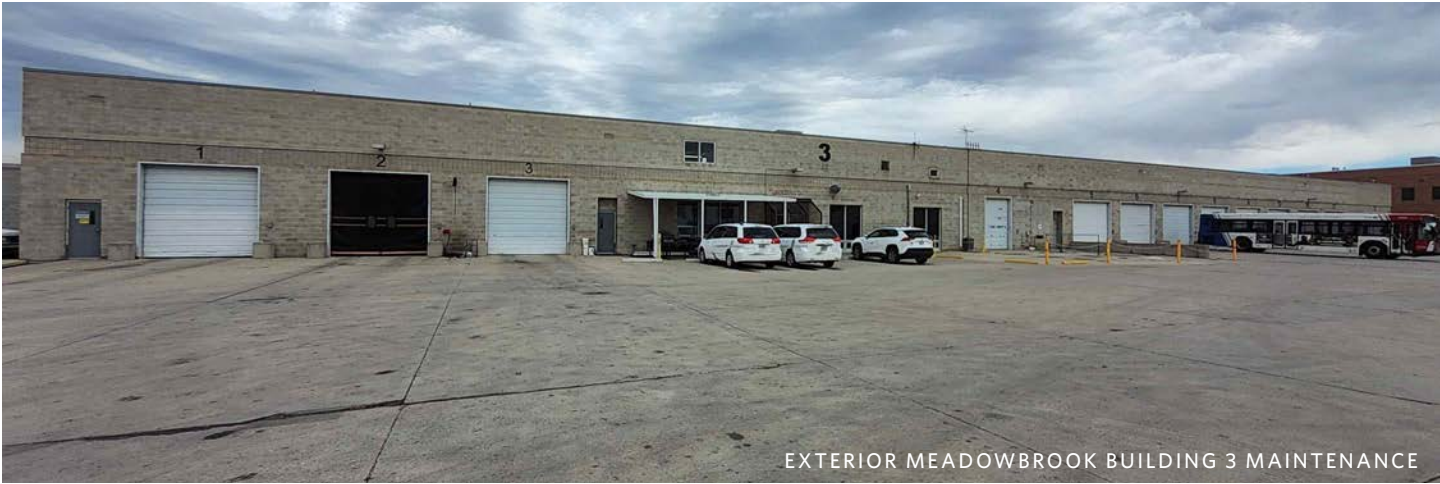
Meadowbrook Building 3 Maintenance building provides a comprehensive service facility for inspecting and repairing UTA's bus fleet vehicles. Additionally, the building has administrative offices, locker rooms, parts storage rooms, and a break room. A 2023 addition added seven maintenance bays to the building.

Ongoing repairs to the building resulting from the damaged fire suppression main will address many deficiencies. MB3 has sufficient maintenance space to support expansions in revenue fleet, however, spaces such as locker rooms, tool storage and areas for desktop work are overcrowded and will need expansion.

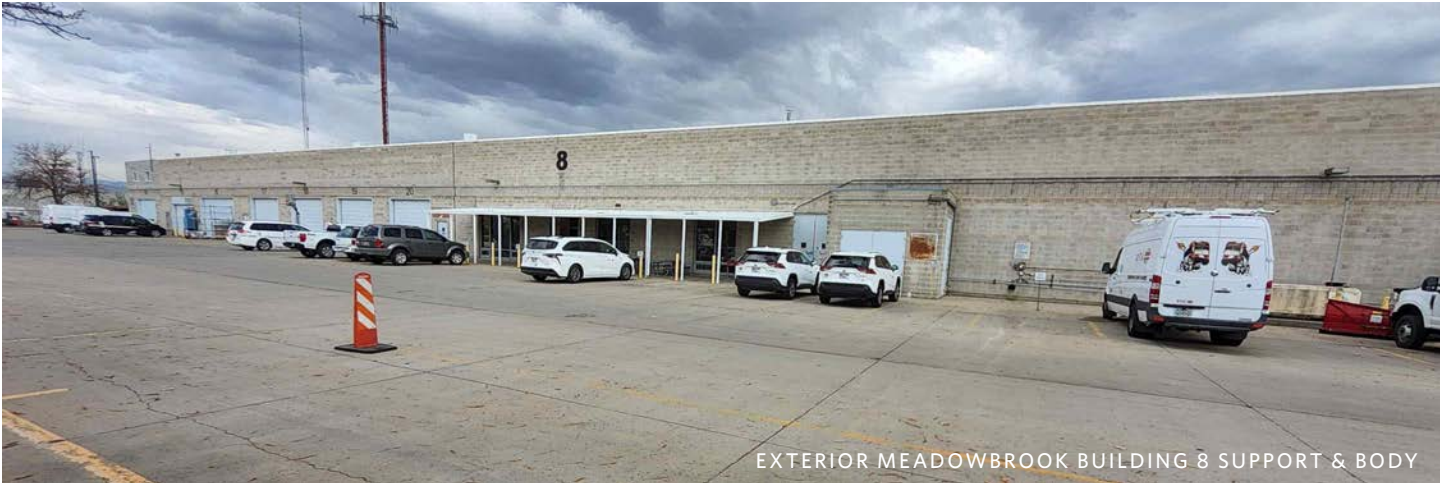
EXTERIOR MEADOWBROOK BUILDING 8 SUPPORT & BODY

Meadowbrook Building 8 houses Maintenance Support & Body Work, including a machine shop, parts receiving department, and paint facilities. Additionally, Facilities Maintenance and Non-Revenue Vehicle maintenance support operate out of MB8.

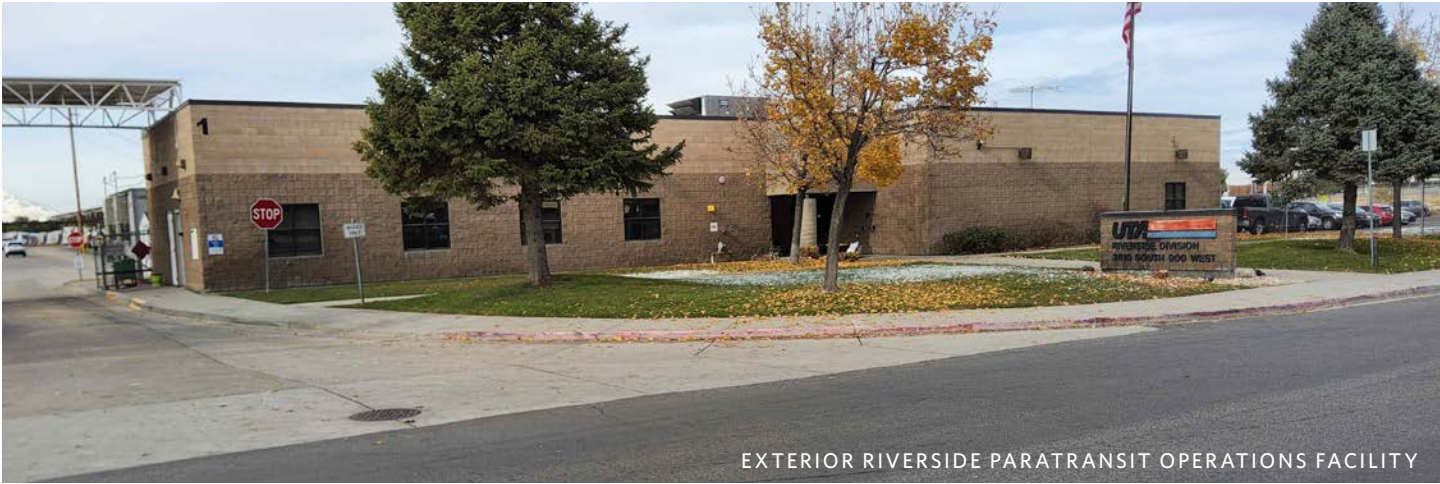
# Riverside | Operations

The UTA Riverside Paratransit Operations provides workspace for UTA’s Paratransit services including operations, dispatch, scheduling, radio and control. The facility is supported by two relocatable buildings to accommodate an expanded workforce.

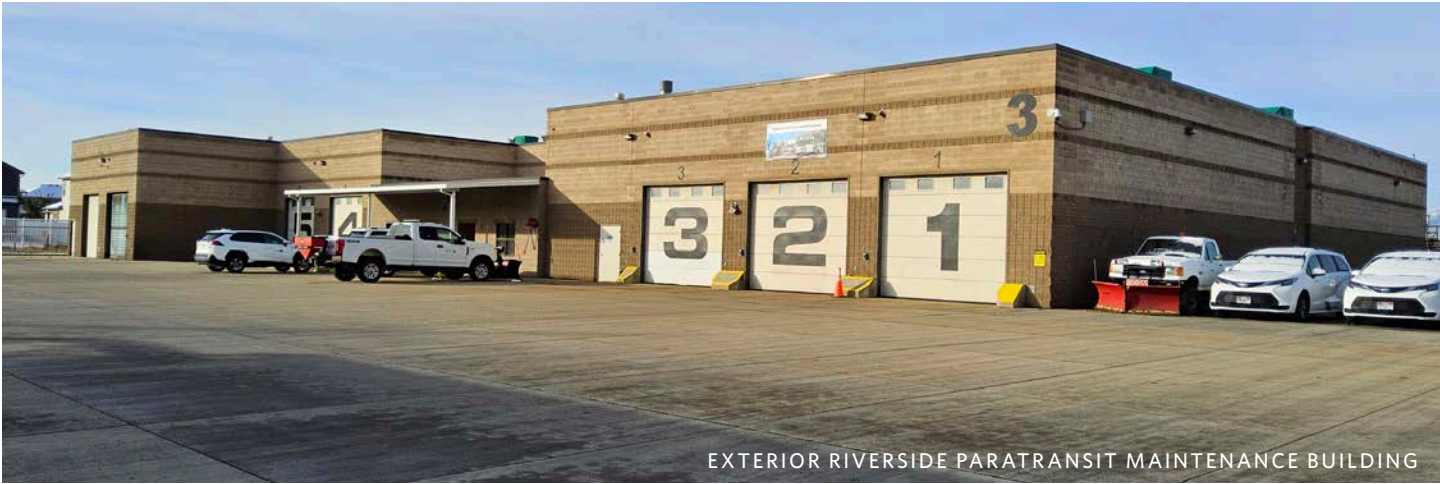
EXTERIOR RIVERSIDE PARATRANSIT MAINTENANCE BUILDING

The Riverside maintenance building provides workspace for maintenance and service of Paratransit and Flex vans, including a space for tire maintenance contractor to work. The building also provides limited locker rooms and administrative work spaces.

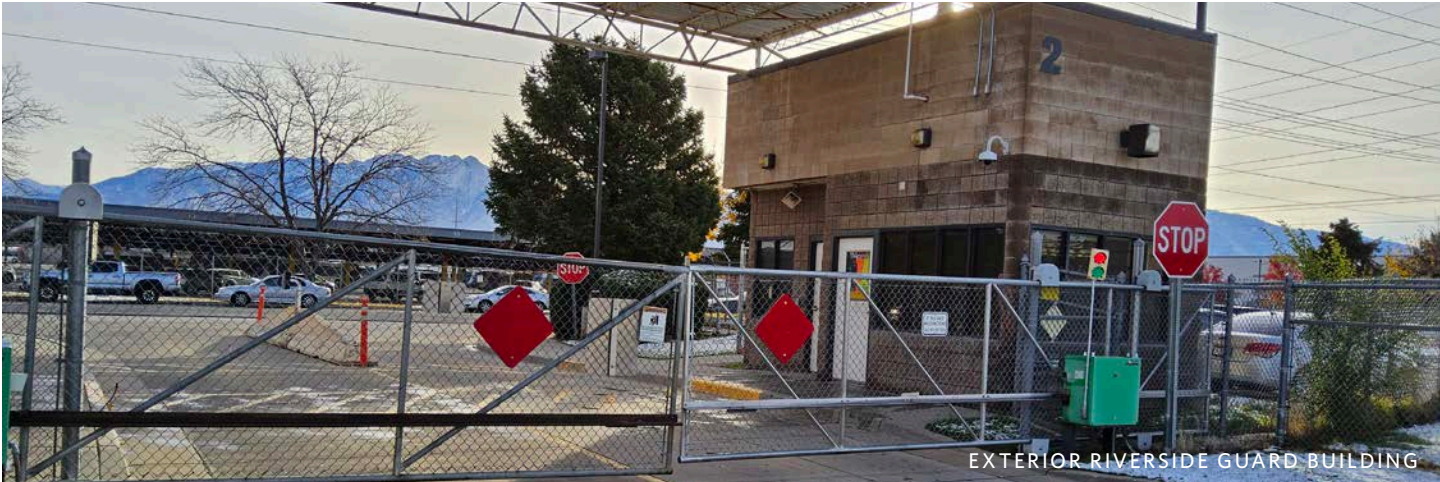
# Riverside | Support Buildings

The Riverside Guard building is a single-story facility used as a security entrance for the site. The Fuel Island contains a number of above ground tanks for diesel, gasoline and other fluids, which are delivered to the Service Building for vehicle fueling.

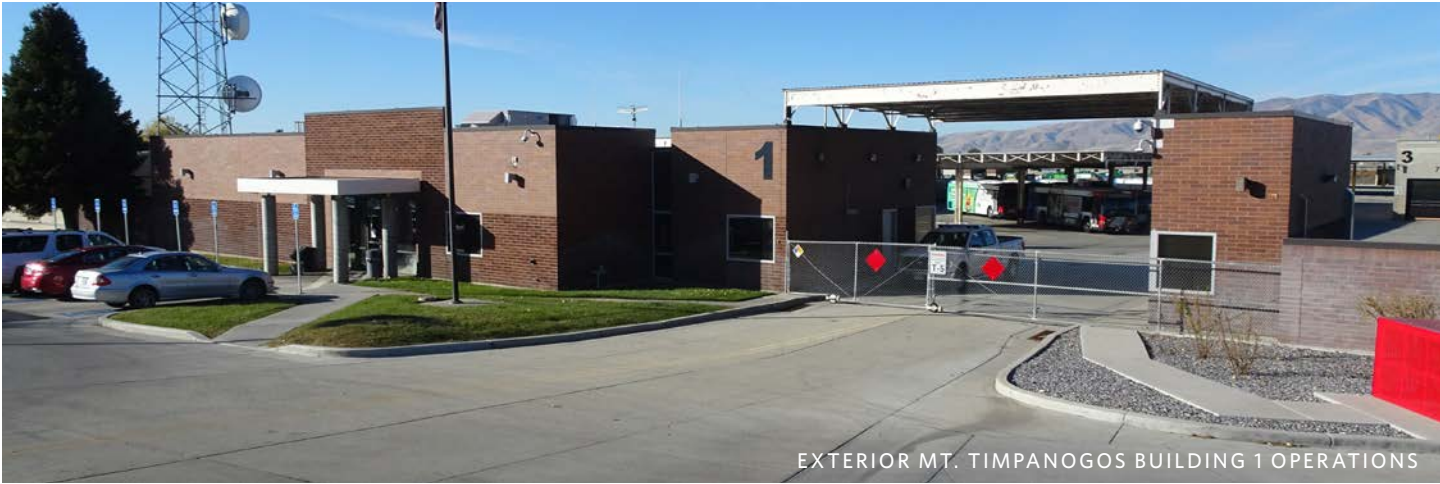
# Mt. Timpanogos | Operations

Mt. Timpanogos Building 1 Operations includes work and support spaces for Administration Operations and Dispatch. The building has overflowed into a complex of relocatable structures, which house office spaces, meeting rooms and network and radio infrastructure.

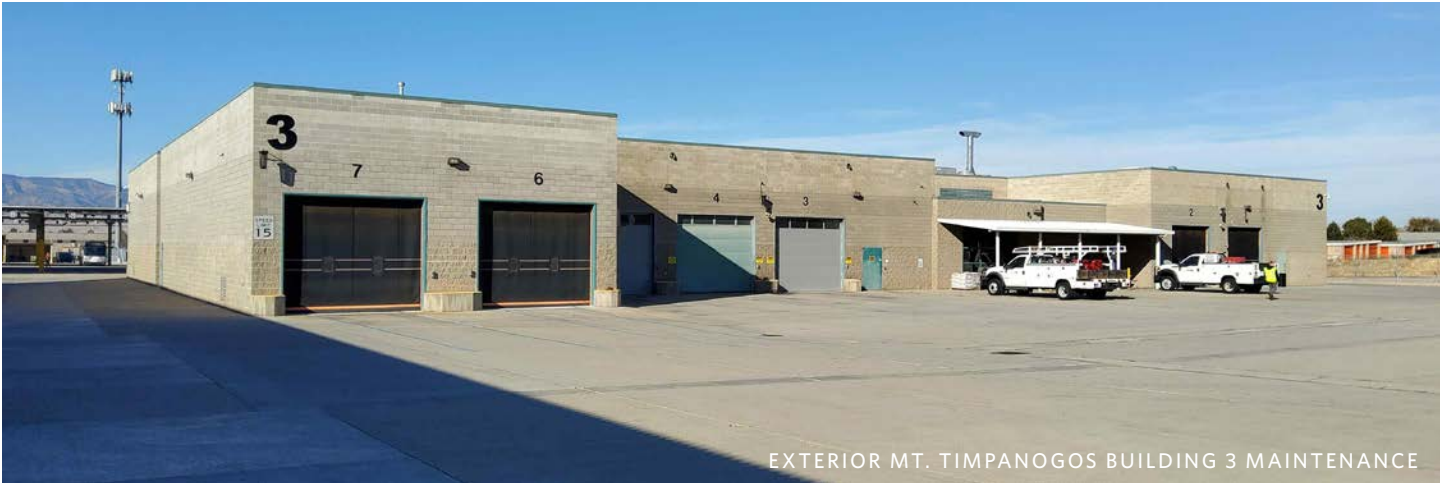
# Mt. Timpanogos | Maintenance

Mt. Timpanogos Building 3 Maintenance provides comprehensive service and maintenance capabilities for UTA buses. To meet the demands of UVX 60 ft articulated buses, an addition was constructed in 2007.

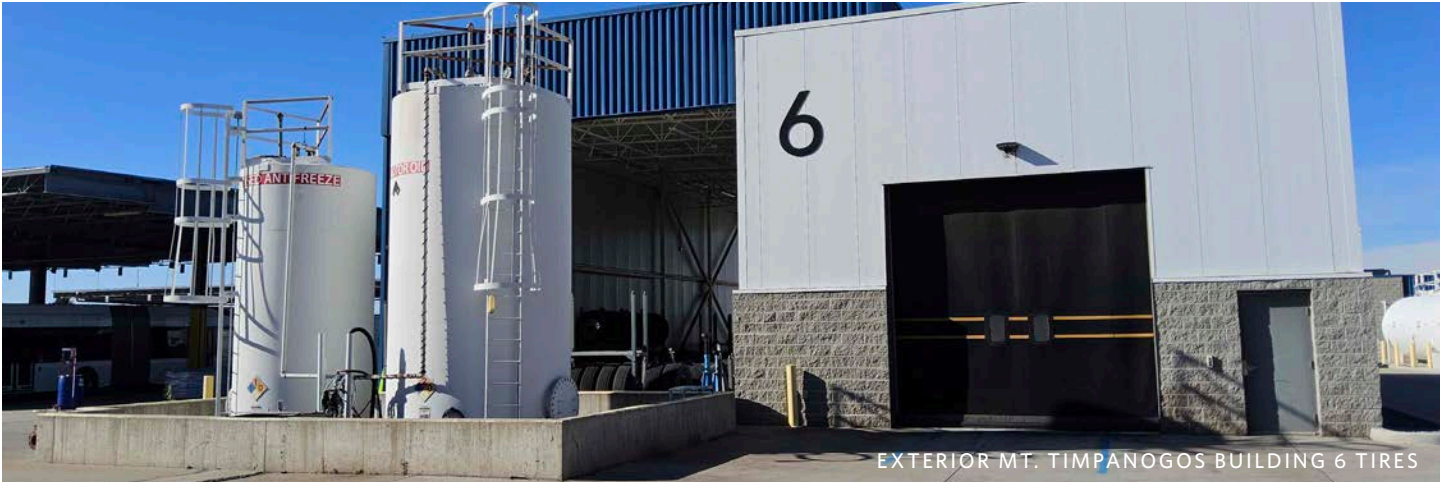
# Mt. Timpanogos | Support Buildings

An original 1988 fueling building has been replaced with the 2017 UVX expansion project, which also added four further buildings, rounding out the capabilities of the service unit. The buildings are in good condition, however the access to the facility is proving to be problematic.

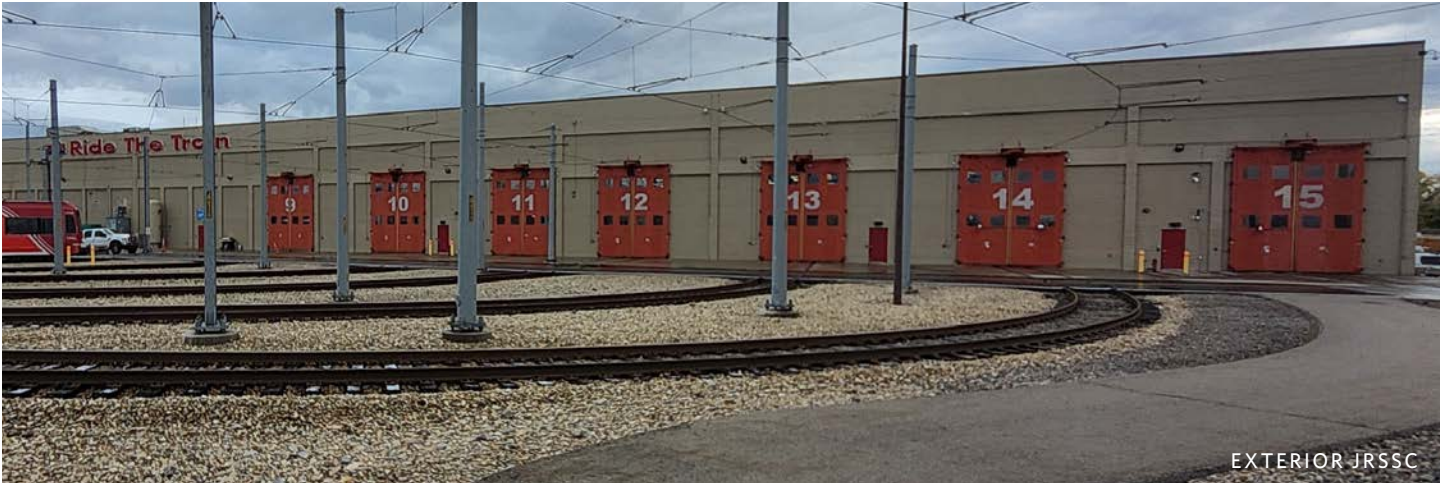
EXTERIOR JRRSC

The UTA Jordan River Rail Service Center provides comprehensive services including storage, routine maintenance, and repairs. The building also hosts a large number of administrative functions and the TRAX control room.

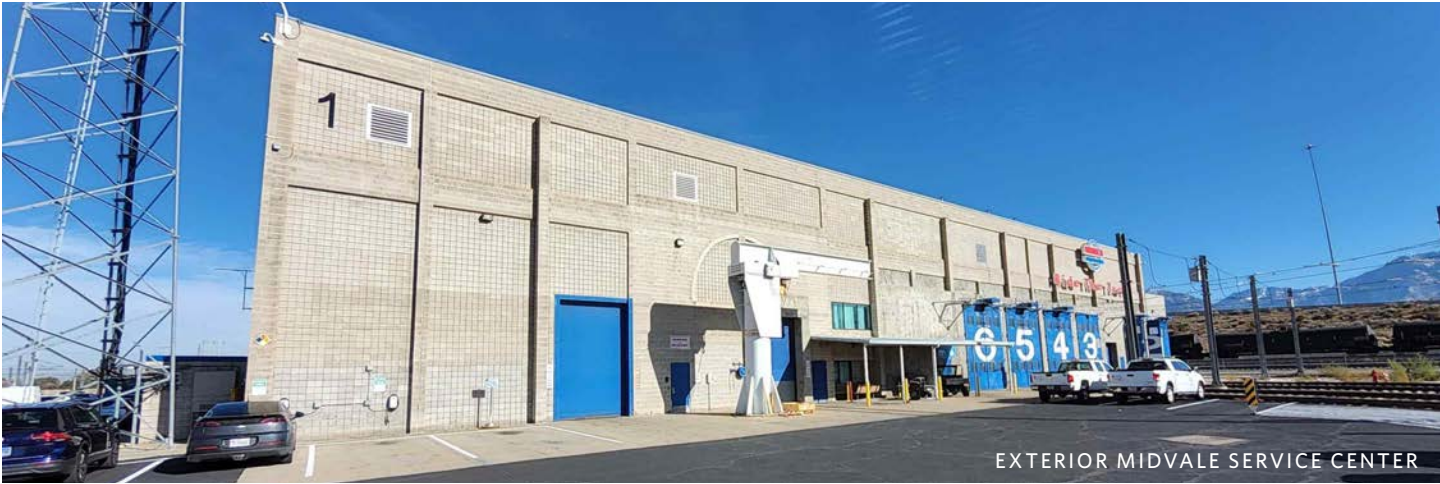
Midvale Rail Service Center was renovated to serve the opening of TRAX and the first generation of LRT vehicles at UTA. Midvale also houses the backup control room for FrontRunner.

Aging and deteriorated equipment are demanding to maintain, and several critical elements of the facility have outgrown their available space. A large scale renovation and expansion project is likely required.

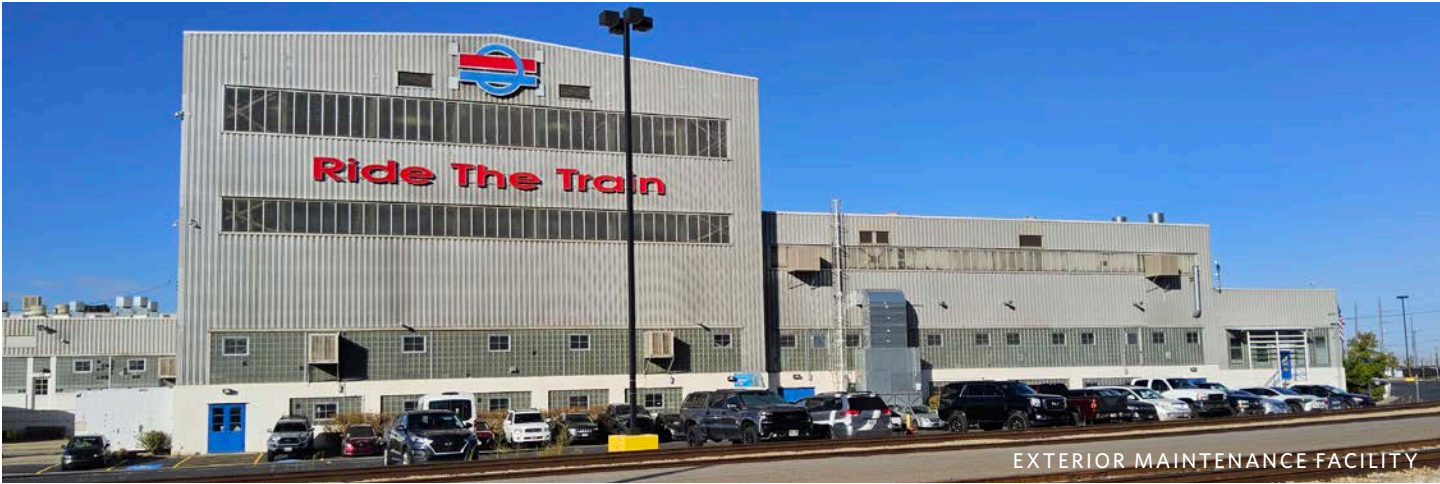
FrontRunner is operated and maintained through a single facility, Warm Springs Rail Service Center, which was built in 1952 as a locomotive assembly plant and adapted by UTA in 2008. The age of the facility and issues with the soils and site mean that there is a number of critical deficiencies, however the unique functions and near 24-7 operations of the building make necessary rehabilitation projects challenging.

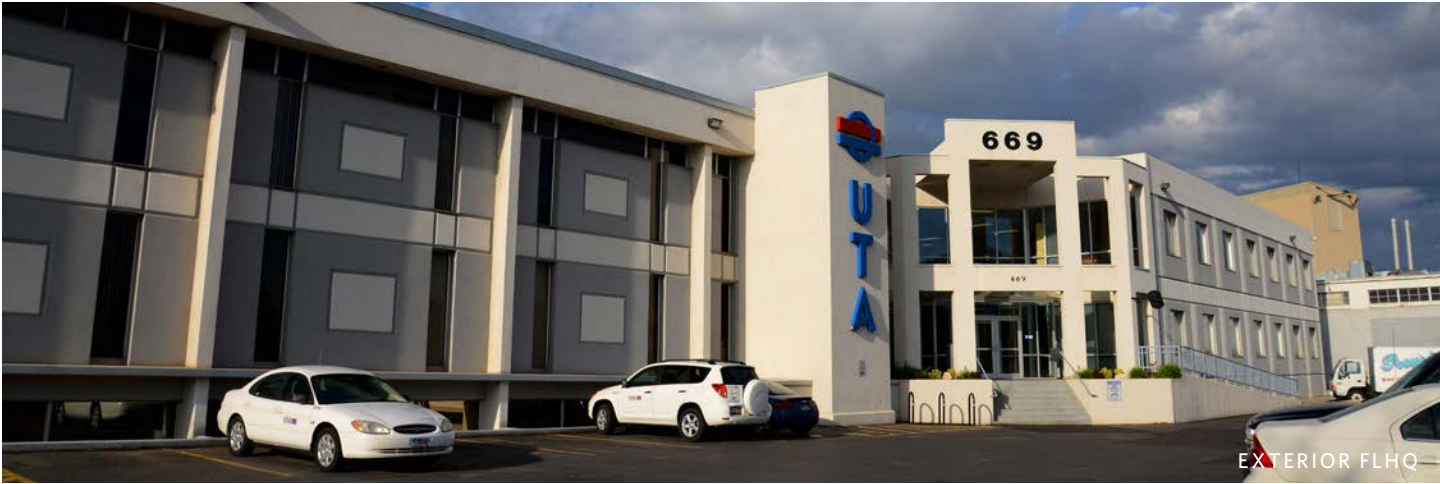
# Depot District | Frontline Headquarters

The UTA Frontline Headquarters (FLHQ) Campus consists of three buildings: East (1966), West (1991), and Connector (year unknown), serving as the primary facility for UTA's administrative and operational needs. The building has undergone various upgrades and additions over the decades, creating a complex infrastructure with mixed-generation systems, prompting the need for comprehensive seismic, architectural, and MEP renovations.

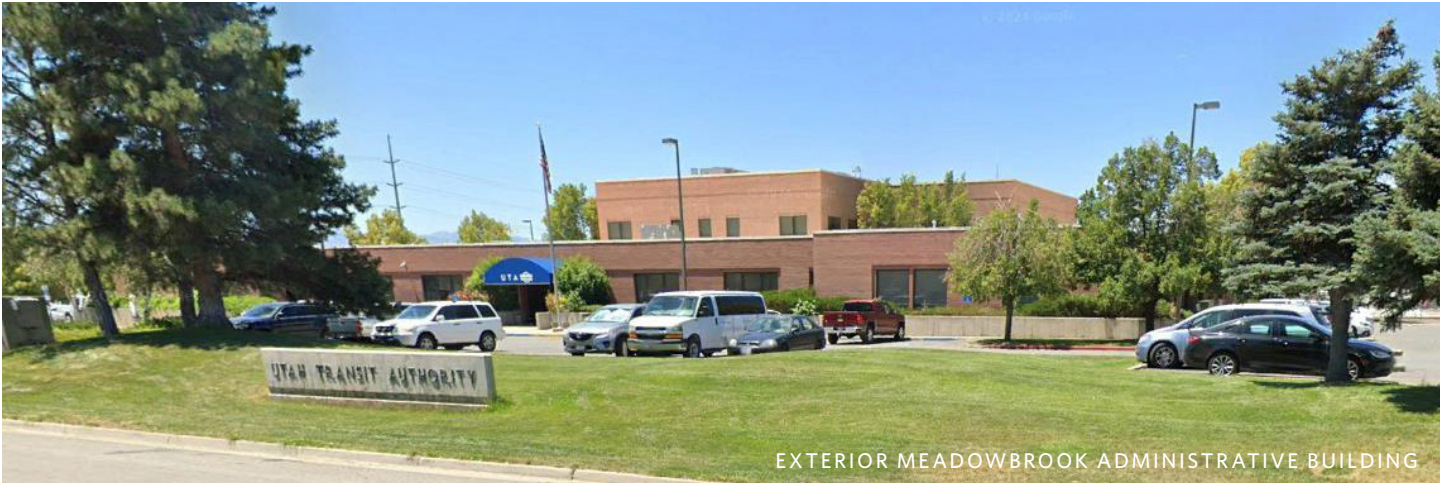
# Meadowbrook | Administrative

Meadowbrook Building 1 Admin. (MB1) building is a two-story facility that includes office spaces, restrooms, break room, storage rooms, classrooms, a healthcare center, and mechanical and electrical rooms.

Despite some aged equipment and building systems, MB1 is a useful building in adequate condition. Network infrastructure is being strategically relocated here, and further growth & consolidation of departments is expected. There will be opportunities during remodels to address deficiencies and ensure the building continues to function well for UTA for many more years.

Communication & Security	Telecom system, security system, and public address system identified for replacement.
	Electrical equipment and systems to be replaced as part of a multi-facility campaign or targeted individual projects. <div>Priority 1: Currently Critical</div> <div>\$537,560</div>

Electrical Distribution	Electrical service, panelboards, uninterruptible power supply, emergency generator, automatic transfer switch, interior distribution transformer and lighting identified for replacement. Electrical equipment and systems to be replaced as part of a multi-facility campaign or targeted individual projects. <div>Priority 1: Currently Critical</div> <div>\$403,081</div>
-------------------------	--

Fire Protection/Suppression	Fire Riser identified for replacement.
	Fire protection equipment and systems to be replaced as part of a multi-facility campaign or targeted individual projects. <div>Priority 1: Currently Critical</div> <div>\$6,230</div>

Elevators/Lifts	Passenger elevator identified for replacement.
	Elevator to be replaced as part of a multi-facility campaign or targeted individual projects. <div>Priority 2: Potentially Critical</div> <div>\$279,460</div>

Mechanical/HVAC	Rooftop units, exhaust fans, AC split systems, control systems, heat pumps, and fan coils identified for replacement.
	HVAC equipment and systems to be replaced as part of a multi-facility campaign or targeted individual projects. <div>Priority 2: Potentially Critical</div> <div>\$246,975</div>

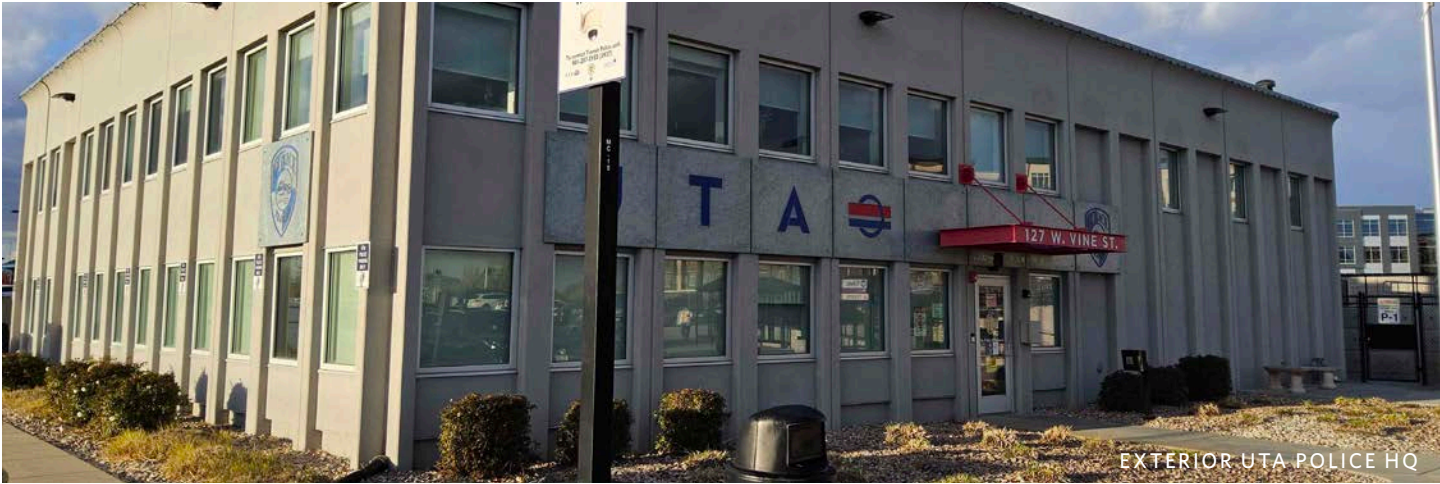
# Police HQ | UTA Police Headquarters

The UTA Police Headquarters serves as the operational center for the Utah Transit Authority Police Department. The building is designed to support the department's various functions, including patrol operations, investigations, K-9 units, and fare enforcement. Equipped with administrative offices, briefing rooms, and secure areas for evidence storage, the headquarters facilitates efficient law enforcement activities across the UTA transit system.

The Police HQ is in adequate condition but space and capability limitations will indicate the need for an expanded building. Police leadership have indicated the desire to accommodate more specialty training and hazardous material storage in their facility, indicating the need for a more secured location. The location of the building at one of UTA's most well-connected transfer points suggests that the building could be successfully repurposed.

Roof and Walls	Gutters and downspouts identified for replacement.	
	Gutters and downspouts to be replaced as part of a multi-facility campaign or targeted individual projects.	
	Priority 1: Currently Critical	\$21,716

Domestic Water Distribution	Gas tankless domestic water heater identified for replacement.	
	Water heater to be replaced as part of a multi-facility campaign or targeted individual projects.	
	Priority 3: Necessary - Not Yet Critical	\$13,350

Exterior Doors	Exterior doors identified for replacement.	
	Exterior doors to be replaced as part of a multi-facility campaign or targeted individual projects.	
	Priority 5: Monitor	\$1,602
